## AN INVESTIGATION

## FIRE RETARDANT CAUSED CORROSION

Final Report

OCEAN CITY RESEARCH

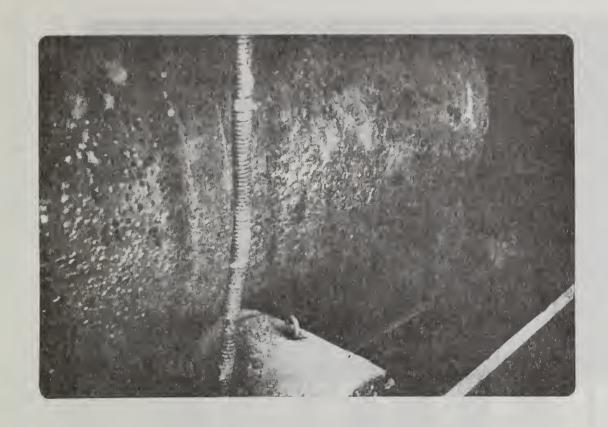
Figure 14 - Typical Coating Deterioration On Fire Retardant Mixing Plant
